# Suffolk Wildlife Trust

## Pond Report for Wakelyns Organic Agroforestry

Visit conducted 4<sup>th</sup> June 2020.

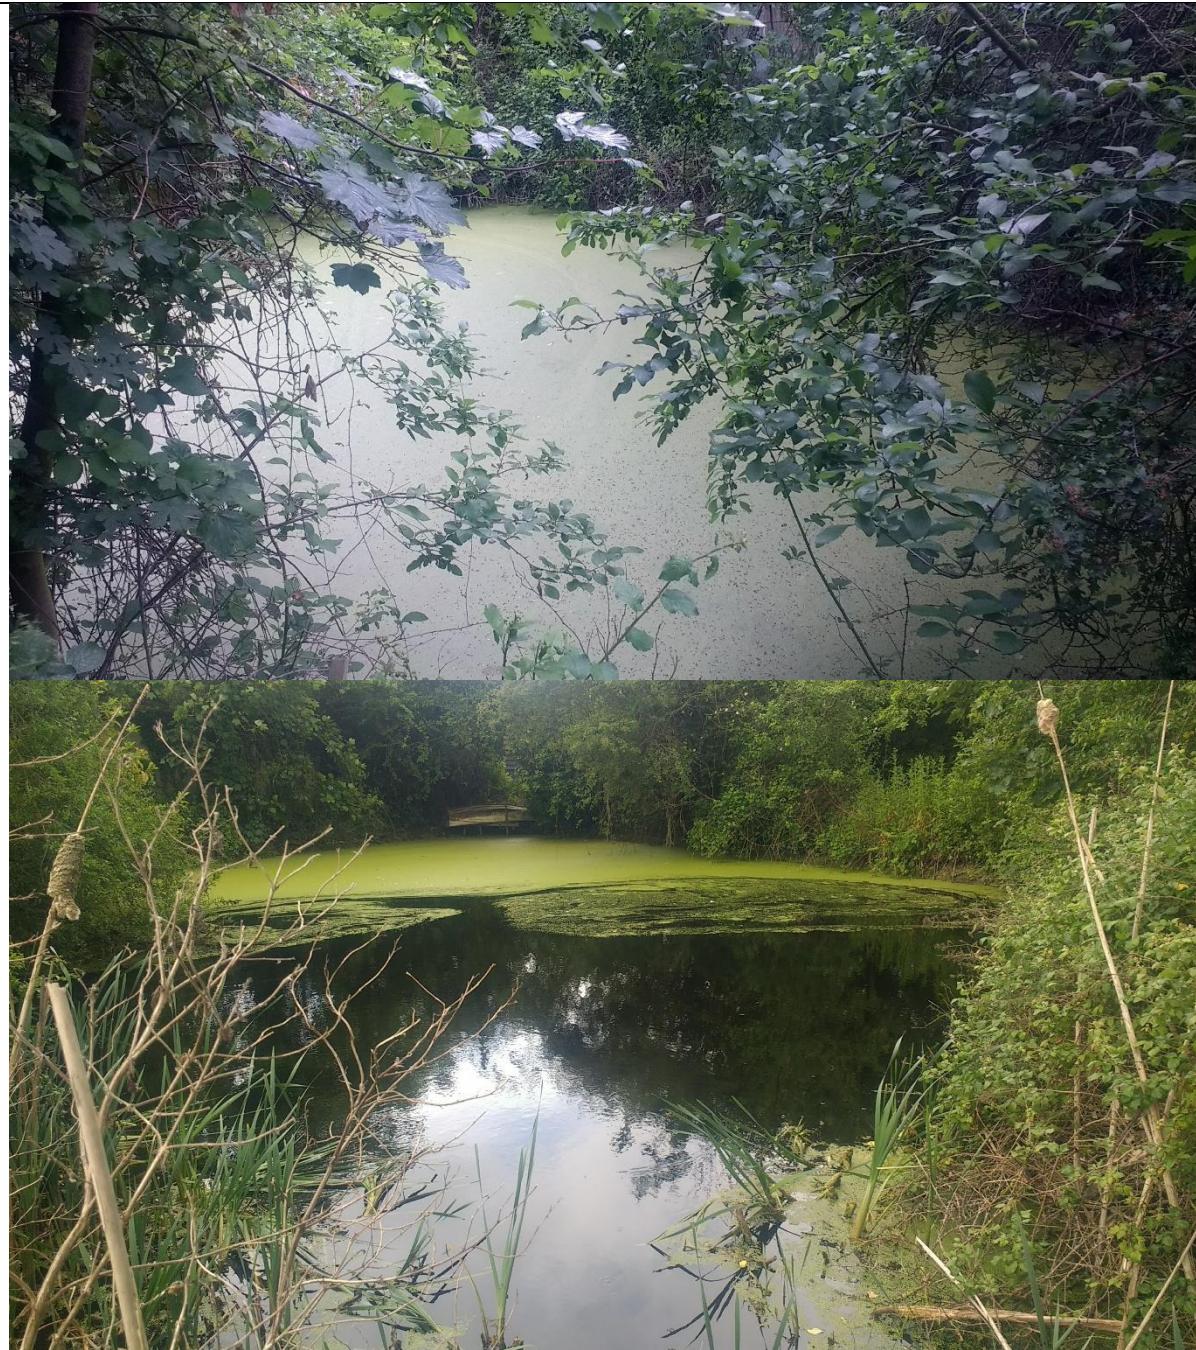
#### Images:

Large Farmhouse Pond, immediately adjacent to farmhouse access and farmyard. 0.02ha. the northern edge is bounded by the agroforestry operation. Pond is duckweed dominated with no visible aquatic macrophytes at the time of survey, some emergent aquatics on the pond edges create a little transitional habitat. The pond is eutrophic and likely has a high organic sediment load suppressing plant growth. Alternatively, there may be fish present, but none were seen on the survey visit – no netting was undertaken. These conditions could also be the result of significant polluted farmyard runoff, although this seems unlikely. The pond appears to be used occasionally for abstraction. The pond is steeply sided and appears to be quite deep, with banks dominated with bramble scrub.

If cyprinid fish are not present, there would be some wildlife benefit to desilting this pond. However, it is likely to be difficult to access much of the ponds perimeter due to its location near the farmhouse and farm buildings. Given these factors and the fact that there are other ponds with greater potential here this pond is of a lower priority for restoration.

Bullrush can become quite invasive, monitor its extent and consider management if becoming dominant.

- Maintain open sunny water by occasionally cutting back vegetation to the south.
- Rotationally manage bankside vegetation to create a range of vegetation growth stages, retaining significant scrub and creating some low clear areas.
- Consider creating shallow sloping banks or bays to provide warm shallow water, consider also historical context of this pond.

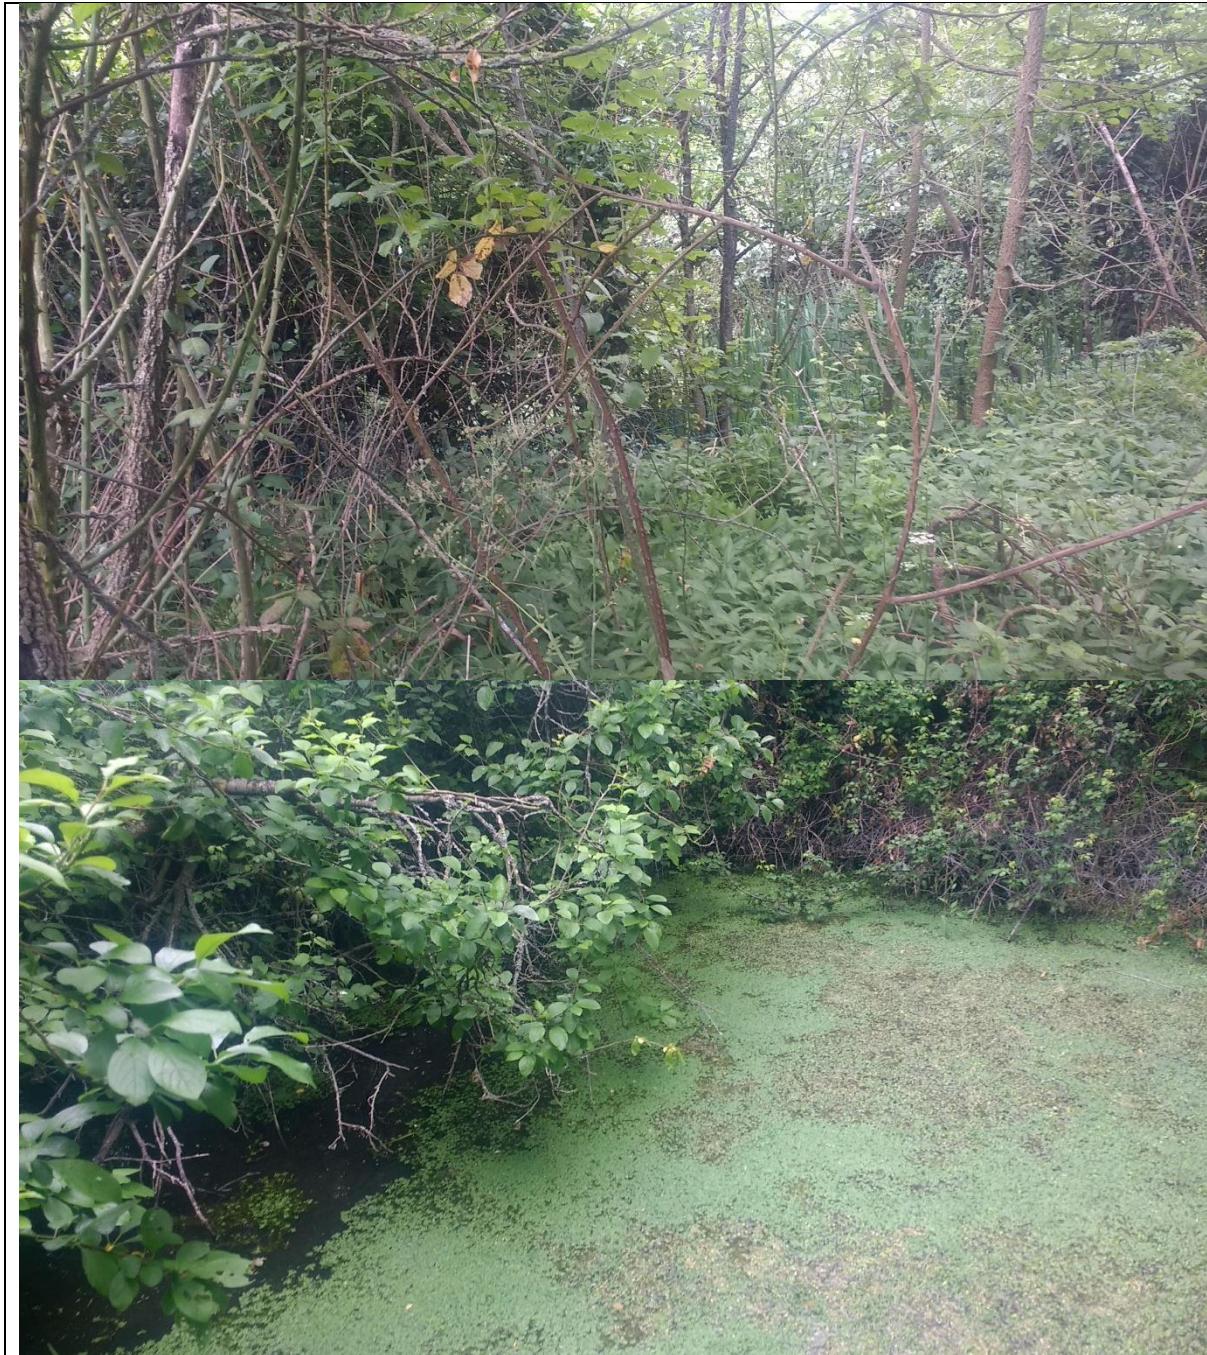
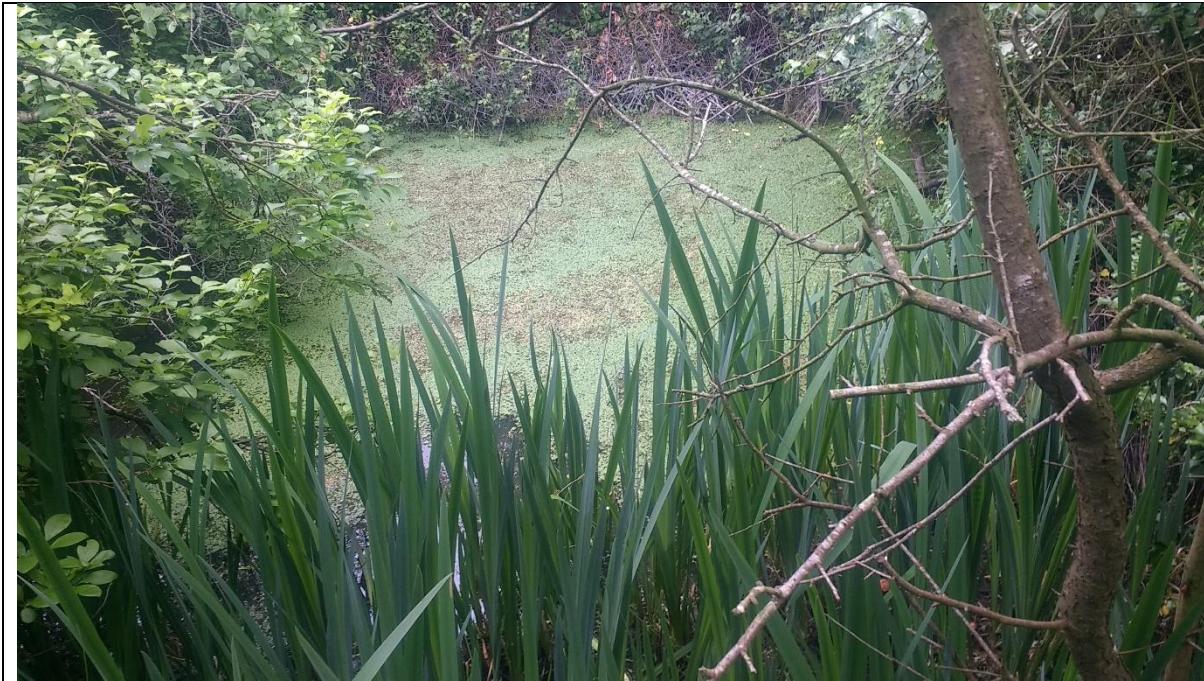
<b>Description:</b> Small farm garden pond, visible in 1880's maps. Steep sided to N, E and W, with shallower slope on S. Entirely shaded by hedgerow and scrub.
<b>Plant Species:</b> Water starwort, <i>Callitricha sp.</i> Flag Iris, <i>Iris pseudacorus</i> Bittersweet, <i>Solanum dulcamara</i>
<b>Amphibian Species:</b> None recorded
<b>Other Biological records:</b> Not made
<b>Management recommendations:</b> The best approach to improve this pond will be to reduce shading from the garden side. It is another that is difficult to access to dredge out, so do this only if you have machinery on site that is able to, suggest first let the light in then reassess in the following years.
<b>Images:</b>

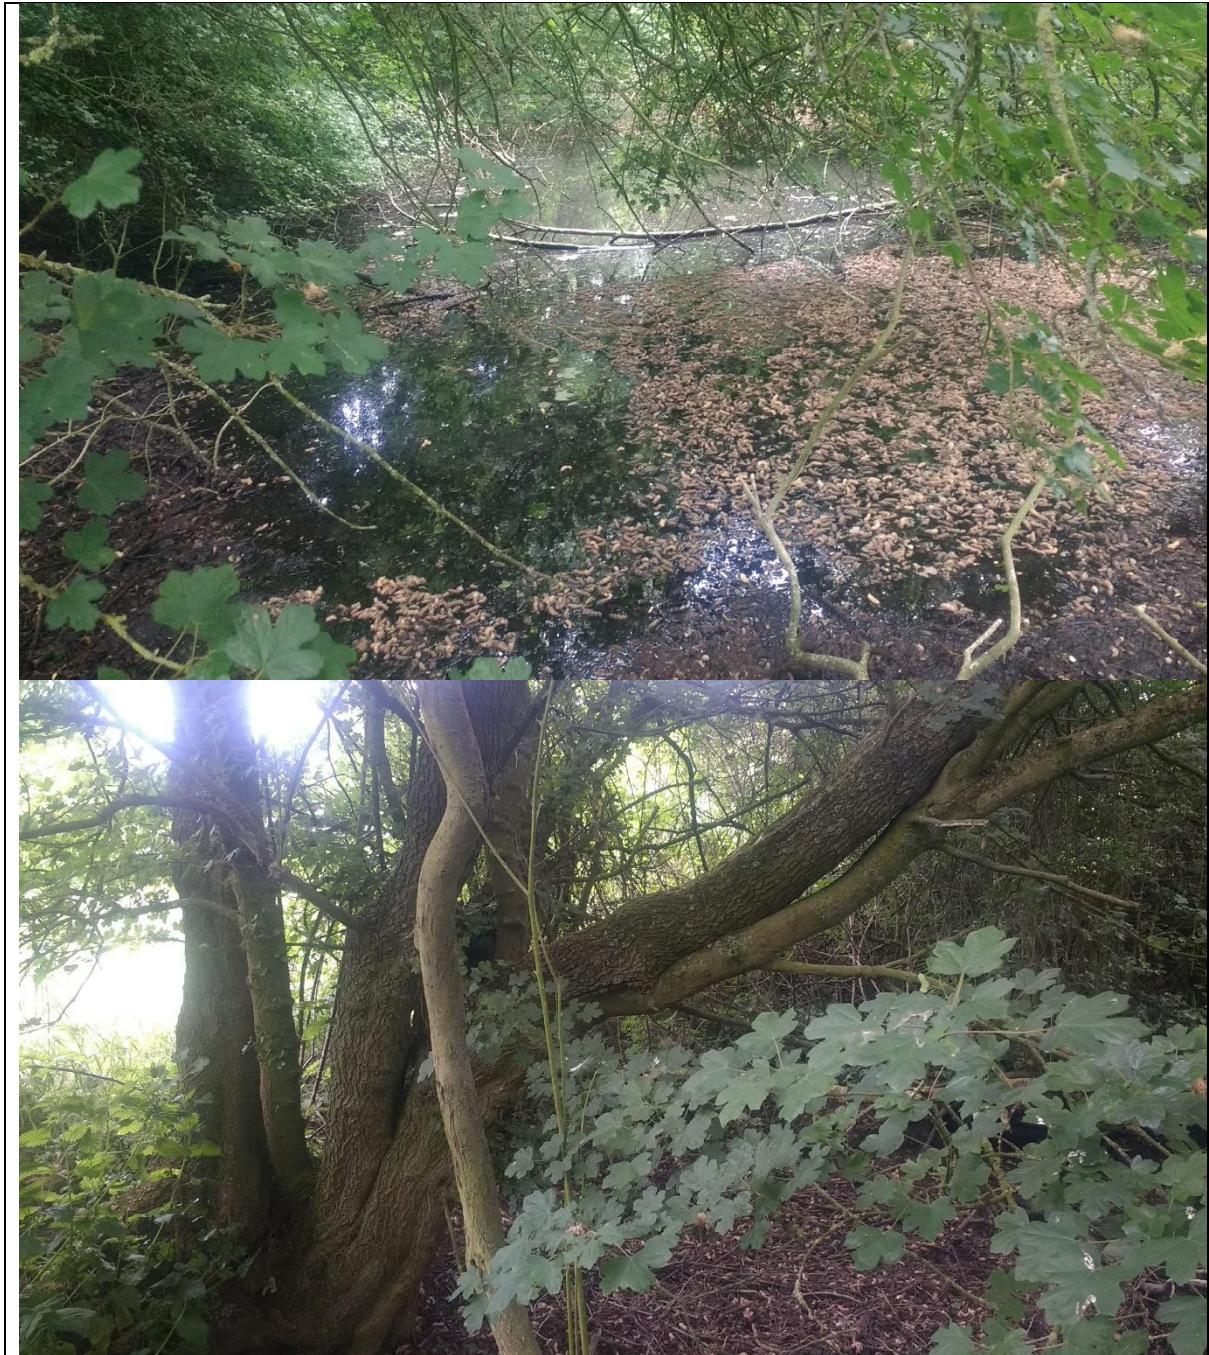
**Images:**

Large pond on corner of driveway, alongside green lane, possibly of some historical significance. The pond runs north to south on the eastern side of the green lane. There are steep sides to the N, E and W of the pond with a gently sloping aspect to the SW corner, which appears to link to the green lane, implying that this may have been access to the pond from the lane in its original use. Currently entirely shaded with blackthorn, sallow and elm, and almost completely silted up, just a few aquatic plants remain. The pond appears to be fed by a field drain that is linked to the organic land, there was clear water within the pond on this visit.

A high priority for restoration. Completely remove shading scrub around the S and E sides. Coppice (or high coppice) the hedgerow adjoining the green lane to the west and thereafter manage as a low hedgerow, retain significant field maple tree specimens. Thereafter desilt the pond to the original clay base – retaining interesting profiles of possible significance.

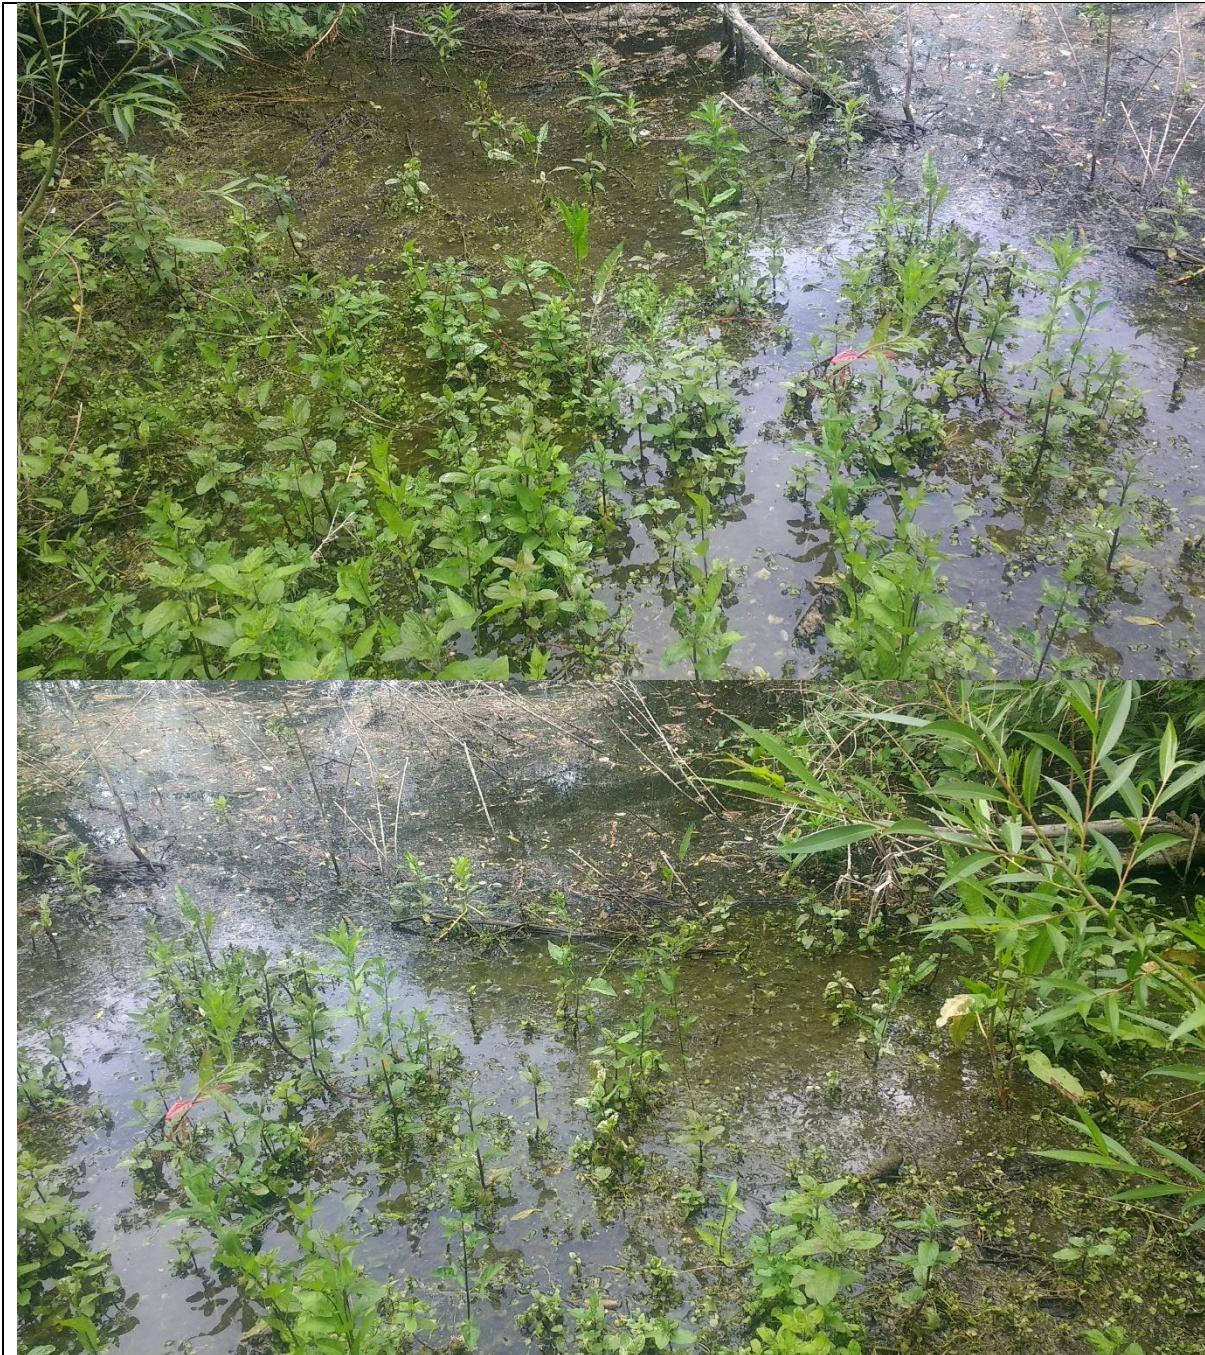
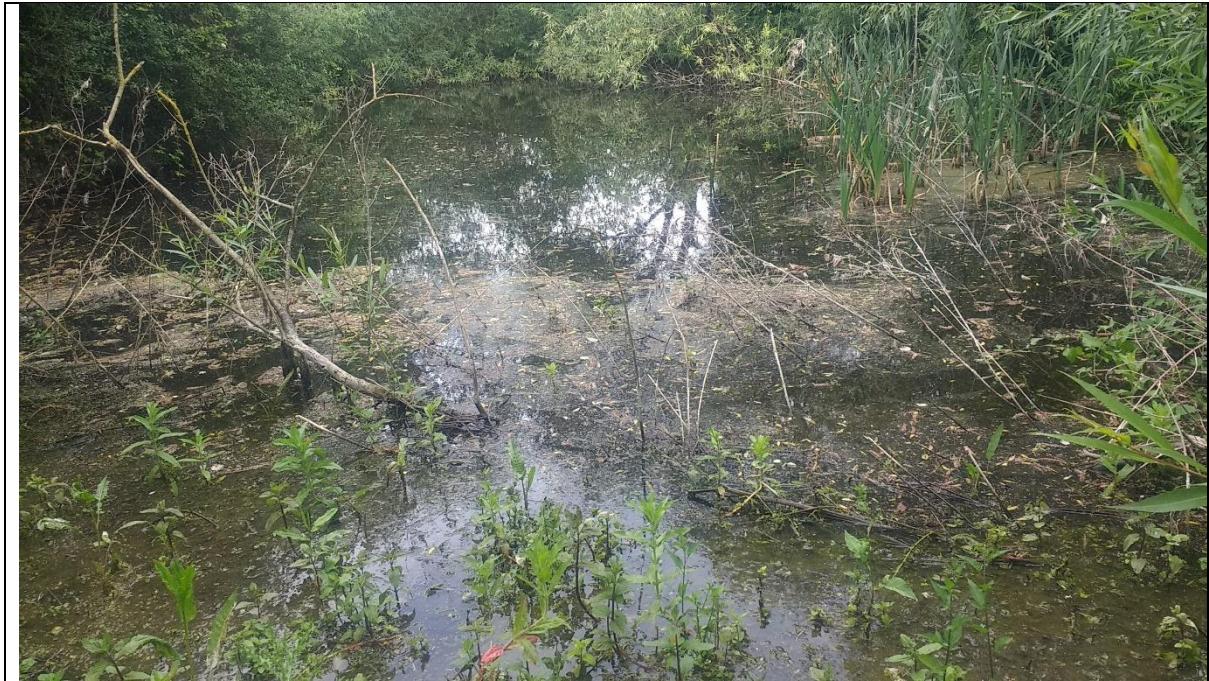
##### Images:

Large roadside pond between agroforestry and industrial unit. Bounded by mature scrub but large enough to be open in the middle. Appears to be deep and steep sided, with shallower aspect to the south. Several aquatic plants in evidence, much woody debris within pond.

Medium priority for management – pond could be subject to polluted runoff from adjoining industrial area. Any restoration undertaken should account for the high quality of the surrounding scrub and be phased so only part of this is lost in any one year – cyclical management of this scrub would be beneficial. Pond holds a good amount of water; pumping would likely be necessary to facilitate effective restoration. Desilting should be considered in future years after pond 3 has been restored and allowed to regenerate for some years.
